TSUNAMI DESIGN FORCES FOR ABC RETROFIT

**Quarterly Progress Report
For the period ending February 28, 2023**

**ACCELERATED BRIDGE CONSTRUCTION
UNIVERSITY TRANSPORTATION CENTER**

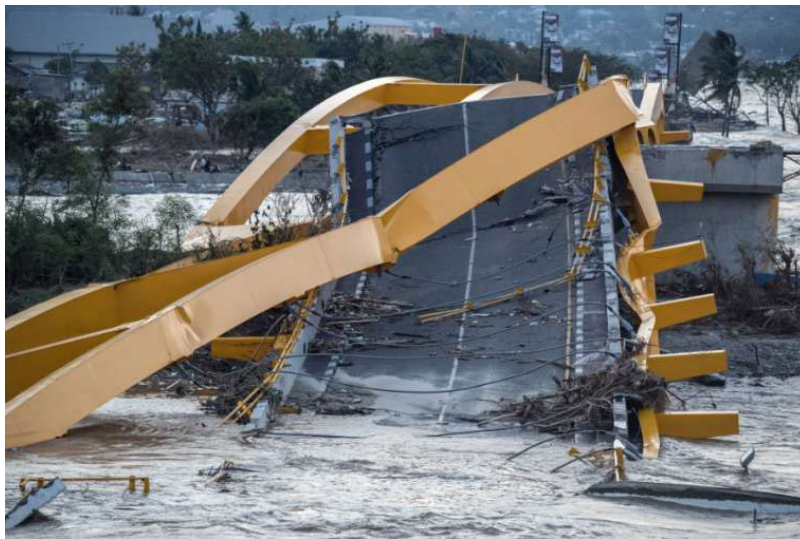
Figure 1. Ponulele Bridge Destroyed by 2018 Tsunami

The catastrophic damage that tsunamis cause to coastal communities is often exacerbated by the destruction of much of the transportation infrastructure, including bridges (Fig. 1). This destruction delays critical rescue efforts and economic recovery.

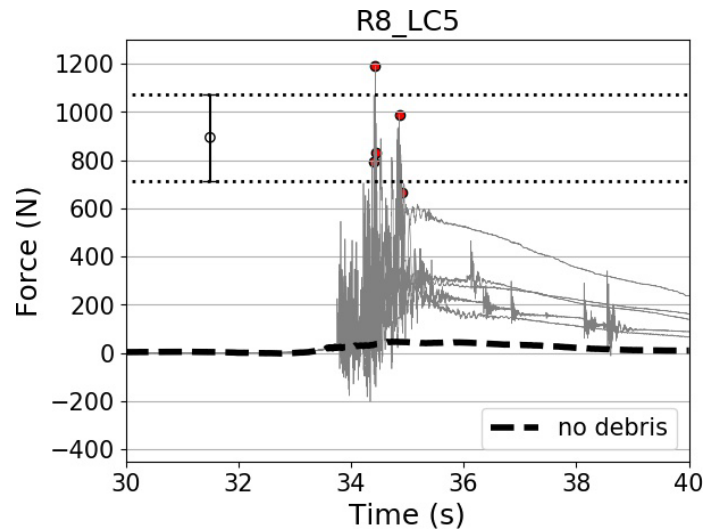
Figure 2. Measured Forces on Elevated Structure

UW and OSU researchers generated an initial set of data using the OSU wave flume. As shown in Fig. 2, the force history (shown for an elevated structure) generated by debris includes multiple impacts (sharp peaks in force history) and an accumulation of force as the debris increases the hydraulic area of the bridge. The forces decrease rapidly with time, because the transient wave lasted only a short time.

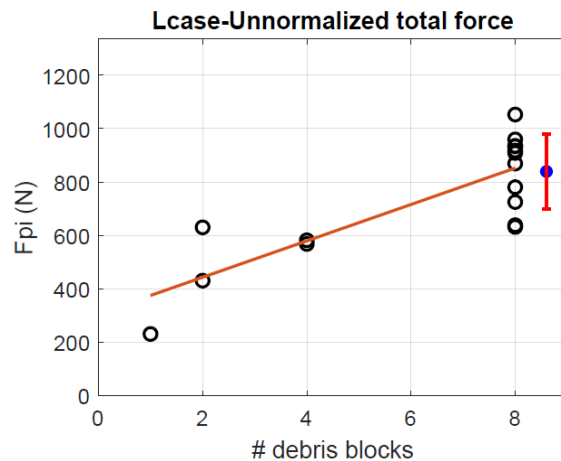
Figure 3. Effects of # Debris on Measured Peak Force

Fig. 3 shows that the total measured force increased with the number of debris in the flow. For eight blocks, this figure also shows that the total force varied greatly among the repetitions, a behavior that is consistent with the semi-chaotic nature of debris interaction with the bridge. This dataset is available from the NHERI DesignSafe data repository (PRJ-1709: NHERI Debris Impact Experiments).

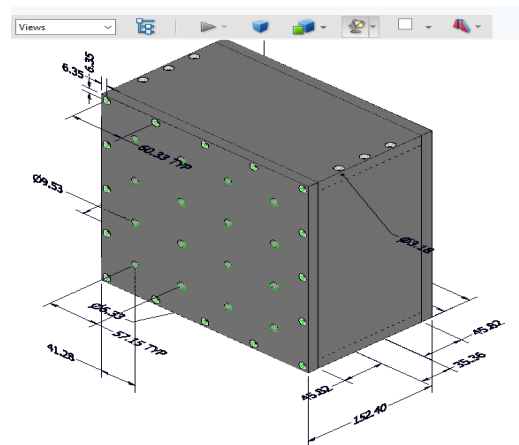
Figure 4. Drawing of Test Structure

The fabrication of the test structure was completed earlier this year, and last quarter we purchased the data acquisition hardware needed to collect and store the test data. Figure 4 shows an isometric view of the test structure.

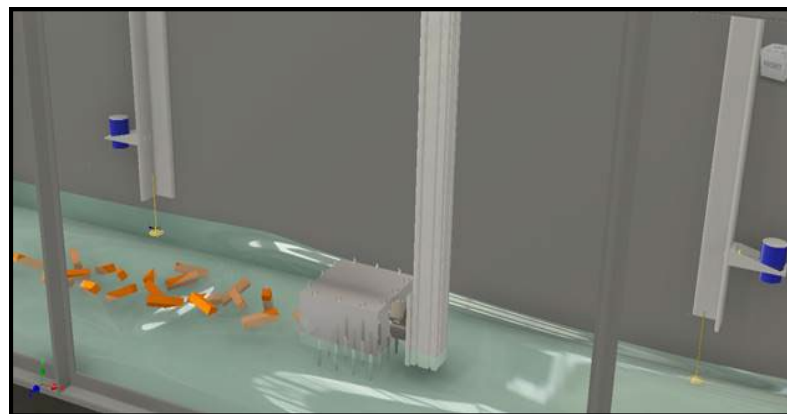
Figure 5. 3D Rendering of Test Setup

Figure 5 shows a 3D rendering of the test setup, in which the current flows from left to right. The structure (shown in grey in middle of image) consists of a waterproof box (fabricated by Mechanical Engineering Department Machine shop), which has attachments to accommodate a wide range of column numbers, locations and heights. The specimen is connected through a 6-degree-of-freedom load cell to a supporting frame (shown as vertical I-beam downstream box). The rendering also shows (in orange) a debris field approaching the structure. The blue cylinders depict ultrasonic gages to

measure flow velocity. The rendering also shows (in orange) a debris field approaching the structure. The blue cylinders depict ultrasonic gages to

measure the elevation of the water upstream and downstream of the structure. These instruments are also supported on their own frames, which attach to the walls of the flume. During the experiments, we will also use existing (and expensive) velocimeter instrumentation to measure current velocity.

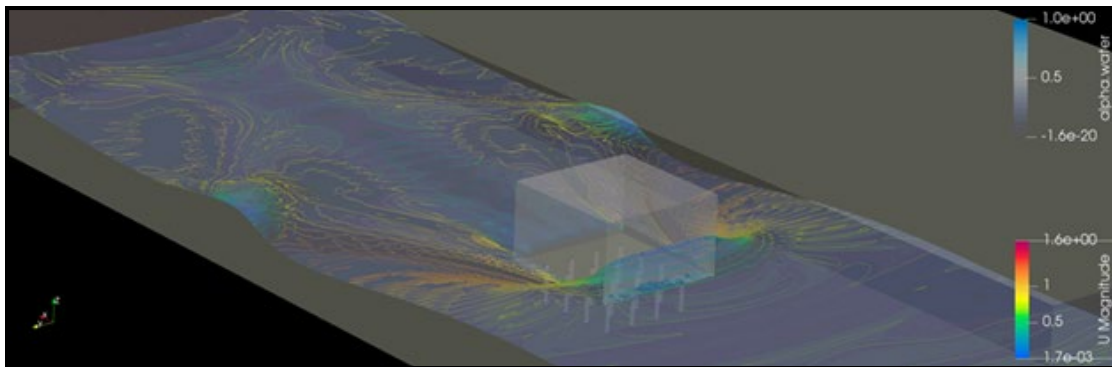
Figure 6. Typical Results of Simulation

To help estimate likely the magnitudes of forces expected in the tests, the team performed 3D simulations using the OpenFoam simulation software (<https://openfoam.org>). Figure 6 shows the results of a simulation of the fluid flow around the structure for the case in which debris is not present.

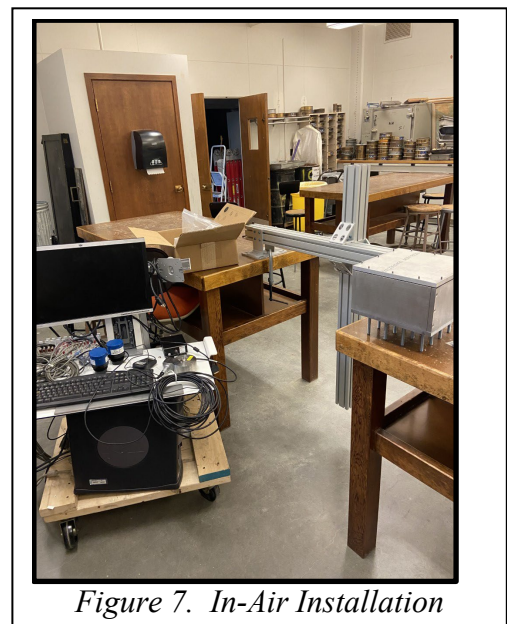
Figure 7. In-Air Installation

The test setup has been assembled outside of the flume (Figure 7). The next step will be to calibrate the 6-DOF load cell before testing can begin in the WASIRF facility.

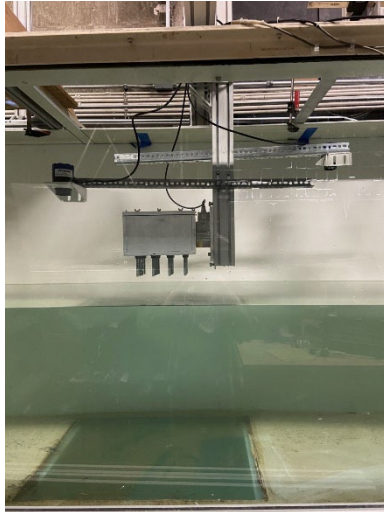
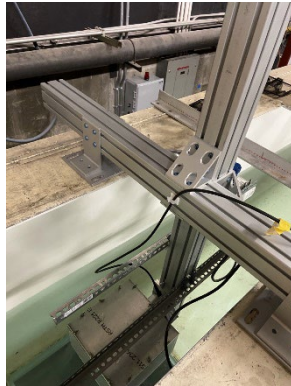
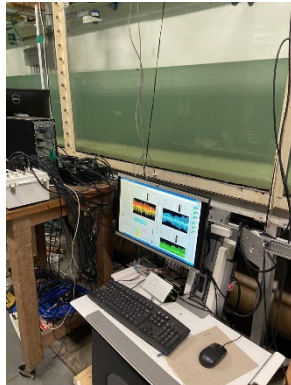
Figure 8. Test Setup in Hydraulic Flume

After long Covid-induced delays, the hydraulic laboratory is now available for experimental testing, and the testing began in the second week of August. It should continue until the end of the month and early September. Figure 8 shows three photographs of the test setup in the flume,

including an elevation of the test setup, a top view of the test setup, and the data acquisition system.

(a) Elevation of Test Setup

(b) Top View of Test Setup

(c) Data Acquisition System
