TSUNAMI DESIGN FORCES FOR ABC RETROFIT

**Quarterly Progress Report
For the period ending June 30, 2023**

**ACCELERATED BRIDGE CONSTRUCTION
UNIVERSITY TRANSPORTATION CENTER**

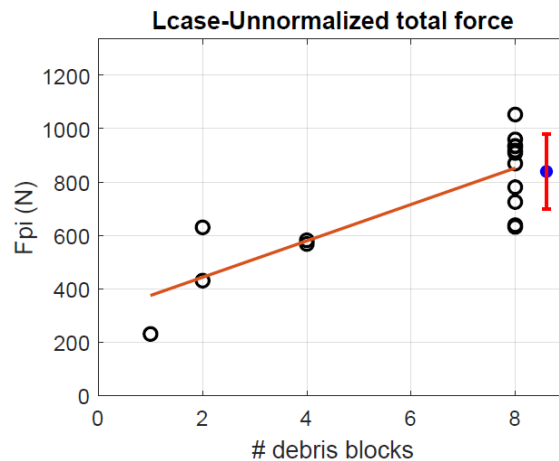
Fig. 3 shows that the total measured force increased with the number of debris in the flow. For eight blocks, this figure also shows that the total force varied greatly among the repetitions, a behavior that is consistent with the semi-chaotic nature of debris interaction with the bridge. This dataset is available from the NHERI DesignSafe data repository (PRJ-1709: NHERI Debris Impact Experiments).

Figure 3. Effects of # Debris on Measured Peak Force
