Subject: **Freezing and Thawing Test Results – ASTM C 666-03 (Procedure A)**  
**TEC Services Project No: TEC 06-0514**  
**TEC Services Laboratory ID: 08-231**

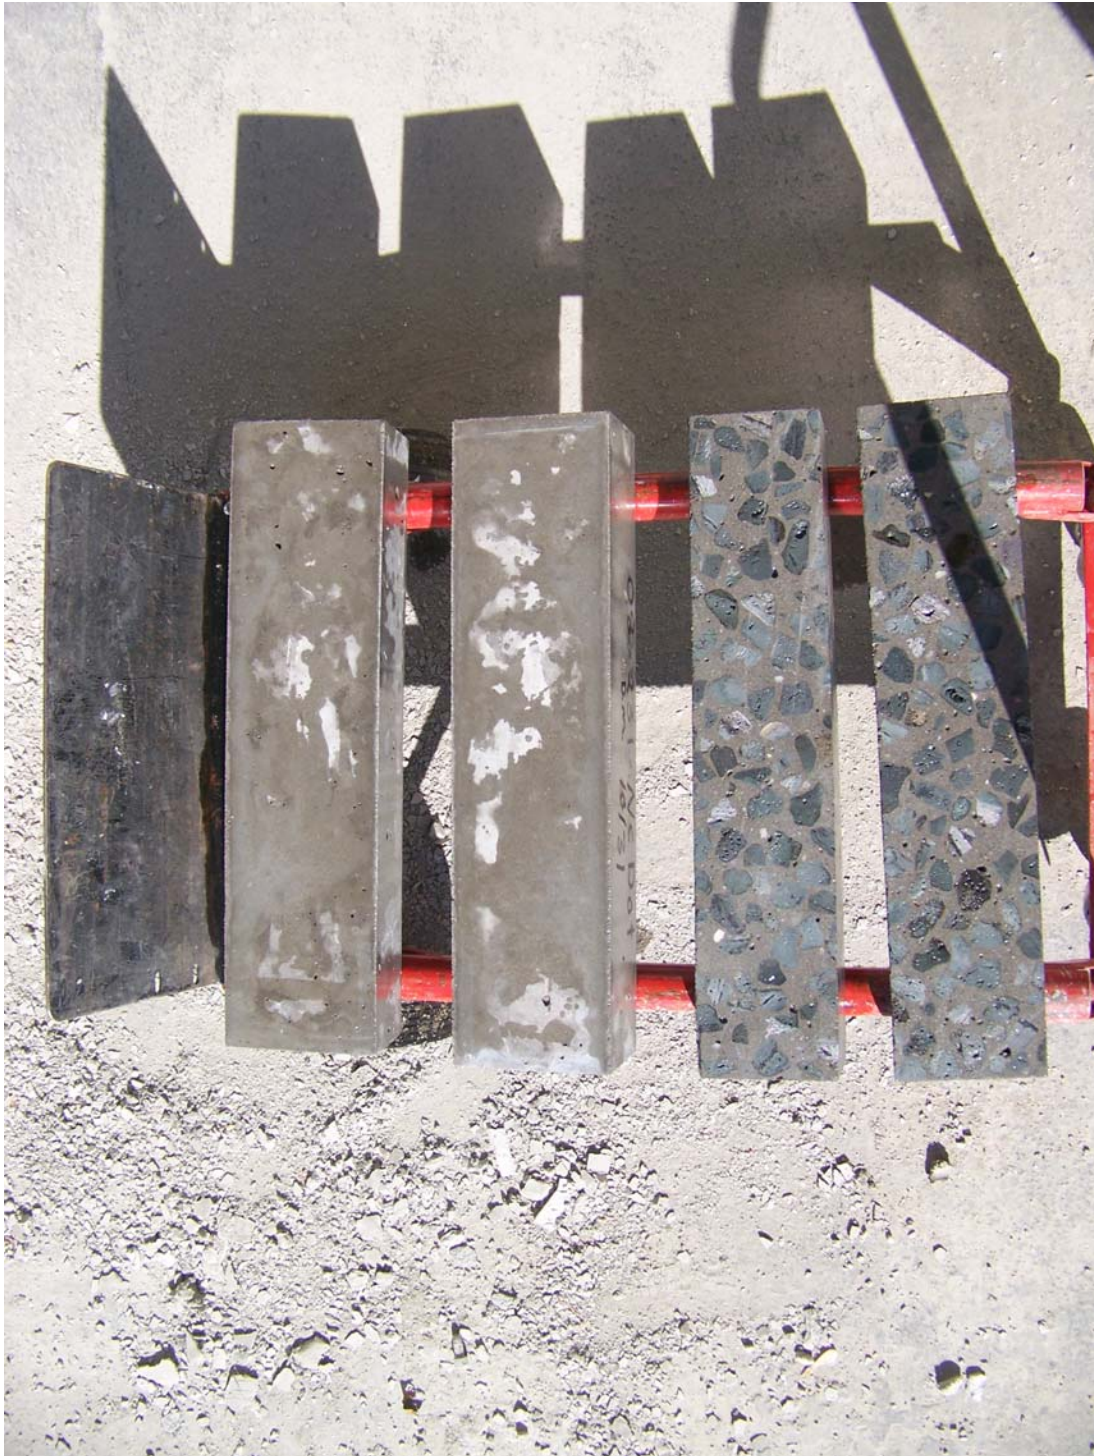
**Photo 1 – Saw Cut Faces of Beams**

<b>Beam #3 - Saw Cut Faces</b>		
<b>Completed Cycles</b>	<b>Fundamental Transverse Frequency (kHz)</b>	<b>Relative Dynamic Modulus (%)</b>
0	1.934	100
30	1.934	100
55	1.934	100
95	1.934	100
138	1.953	102
179	1.934	100
209	1.934	100
240	1.934	100
280	1.934	100
<b>307</b>	<b>1.934</b>	<b>100</b>
<b>Beam #4 - Saw Cut Faces</b>		
<b>Completed Cycles</b>	<b>Fundamental Transverse Frequency (kHz)</b>	<b>Relative Dynamic Modulus (%)</b>
0	1.934	100
30	1.914	98
55	1.914	98
95	1.914	98
138	1.914	98
179	1.914	98
209	1.914	98
240	1.914	98
280	1.914	98
<b>307</b>	<b>1.914</b>	<b>98</b>
