# Fiber Reinforced Polymer (FRP) Composite Bridges in West Virginia

Compiled by  
West Virginia University  
Constructed Facilities Center

June 2015

Data provided herein is compiled from Inspection Records provided by the West Virginia Department of Transportation – Division of Highways, personal correspondence from WVDOT-DOH officials and reports completed by the West Virginia University – Constructed Facilities Center. Data on the current condition and maintenance issues of the bridge is paraphrased from the WVDOT-DOH Inspection Reports.

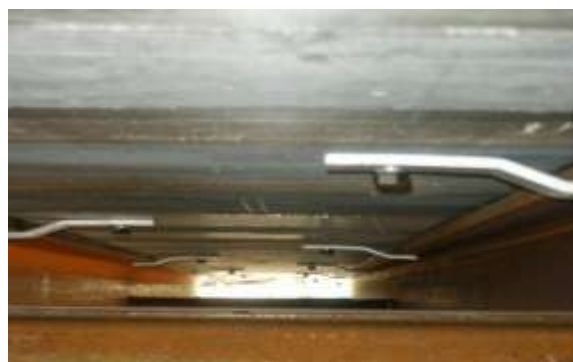
Z-CLIPS ATTACHING DECK TO BEAMS

**Applicable Maintenance Issues:** In 2010, state forces fastened the loose Z-clips, reinstalled the neoprene pads, and welded a keeper angle to hold the pads.

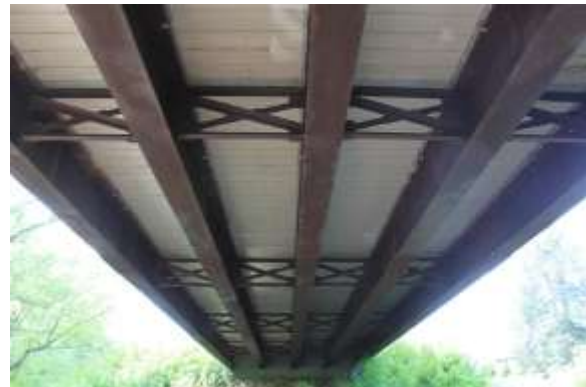
BOTTOM OF DECK

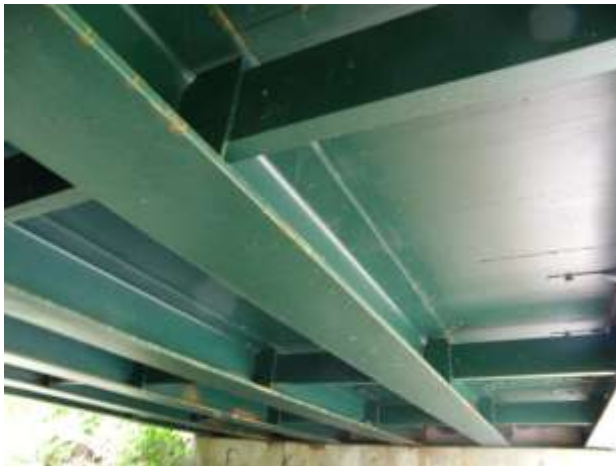
UNDERSIDE OF DECK

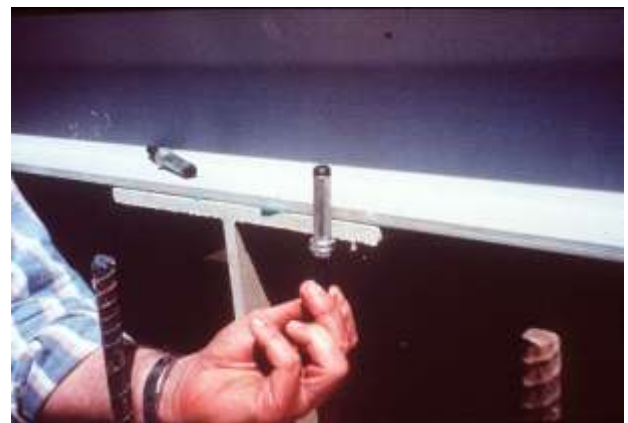
**Current FRP Condition:** The deck is in good condition. A few of the fasteners are loose. The wearing surface is in fair condition. Transverse cracks have developed in the wearing surface at the joints between the four pre-constructed deck panels. Corresponding cracks have developed in the concrete curbs. Cracks are also present over the joint between individual FRP planks and delaminations and map cracking exist. A few areas of missing wearing surface are also present. Water tends to stand on the deck near Abutment 2.

GALVANIZED STEEL BLIND BOLT (POP RIVET)

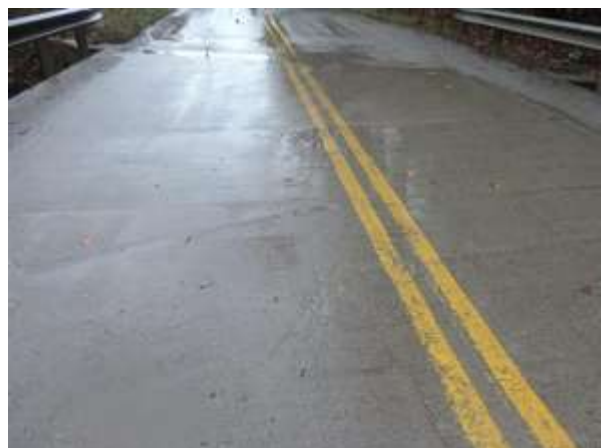
**Current Deck Condition:** The deck remains in fair condition. The top surface is slightly uneven due to the finishing technique. Hairline to 1/16" map cracking, with some water staining, is noted throughout the entire deck surface. The 2007 inspection observed "light cracking", while the 2009 inspection observed "an array of longitudinal hairline to 1/16" cracking in numerous areas". The inspectors believe the GFRP reinforced concrete deck is showing signs of advancing distress and should be dealt with accordingly. However, a relatively smooth ride is provided across the structure.

MAP CRACKING IN DECK

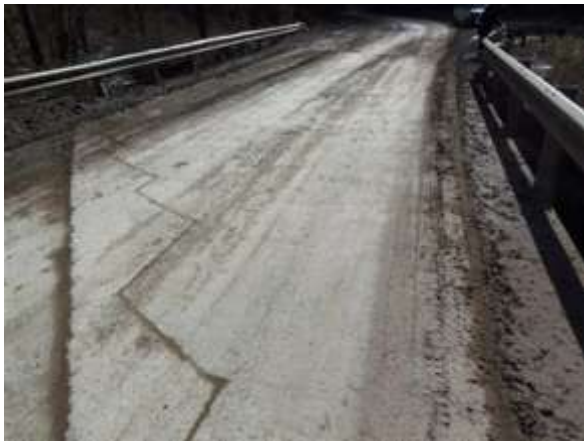
**Current Deck Condition:** The deck remains in fair condition, with hairline to 1/32" map cracking near Abutment One, longitudinal hairline to 1/32" cracking extending from the map cracking towards Abutment Two over Beam Four, a transverse/diagonal hairline crack over Beam Two at Abutment Two and exposed aggregate and a roughened deck surface in the wheel paths. A vertical hairline to 1/16" crack was also observed in the exterior upstream side just forward of the first guardrail post. Despite these deficiencies a relatively smooth ride is provided across the structure.

DECK SURFACE

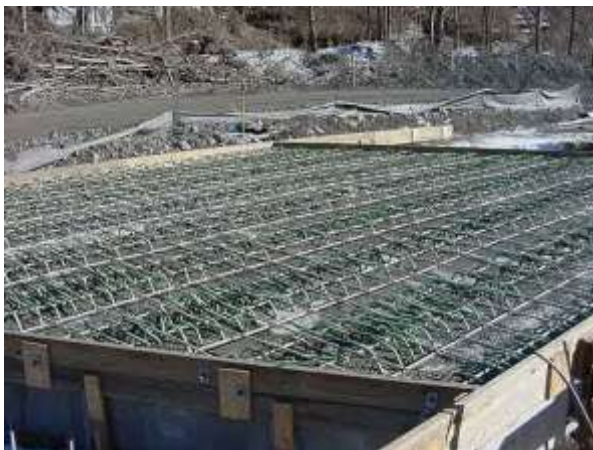
GFRP REBAR IN DECK

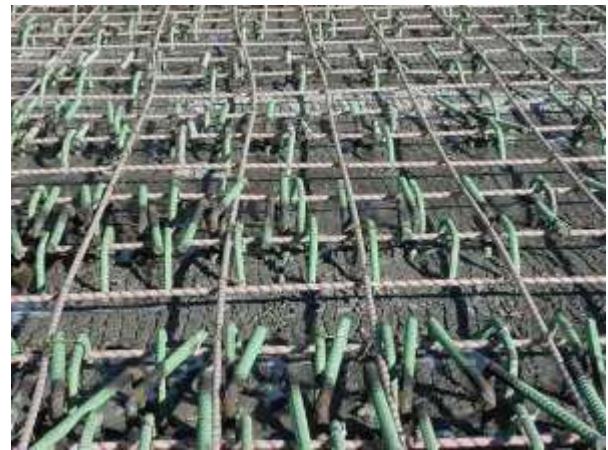
CLOSE UP OF REBAR

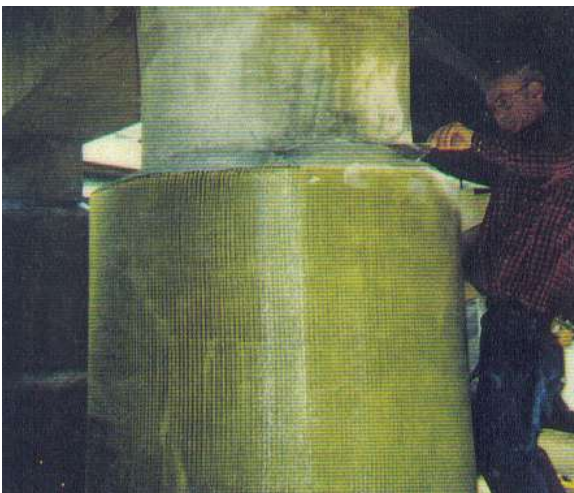
**Applicable Maintenance Issues:** The columns in Pier 1 were encased in concrete in 1990 to repair damage due to a fire. In 1998, these columns were repaired with FRP wraps and shells to provide confinement to the concrete to address cracking in the original repair. Three of the columns were repaired again in 2008 following another fire that damaged the 1998 FRP repair.

FRP WRAP INSTALLATION

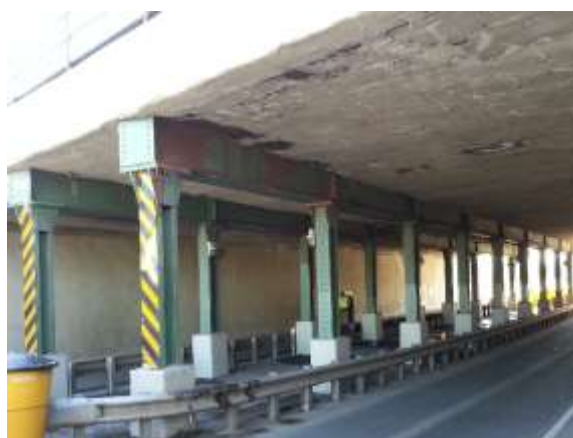
**Current FRP Condition:** The FRP wrap is still in good condition and there are no indications of any problems with the underlying concrete. The 3'-0" reinforced concrete top slab is still in fair condition. There were no apparent problems with the fill or tracks.

UNDERSIDE OF BRIDGE

**Applicable Maintenance Issues:** In 2012, state forces painted fiberglass, touched up FRP, and made minor repairs to the FRP headwall over the southbound lane.

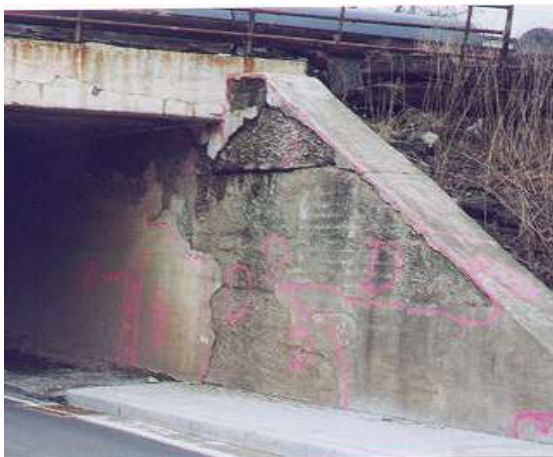
WINGWALL PRIOR TO REHABILITATION

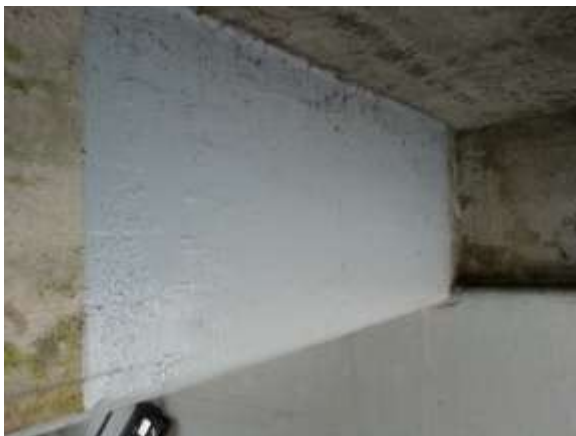
FRP ON END OF T-BEAM

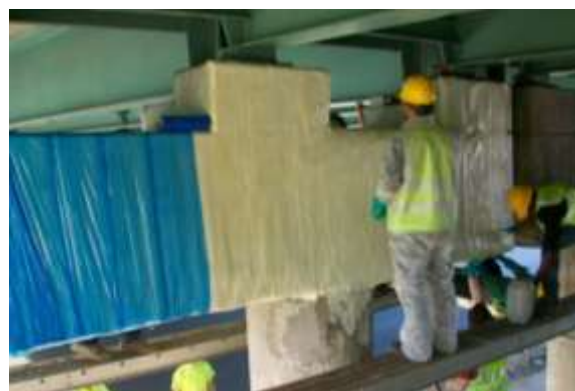
INSTALLATION OF THE FRP WRAP

In 2014, FRP wraps used to rehabilitate piers 1 and 2 due to deterioration due to rebar corrosion leading to failure of concrete cover.

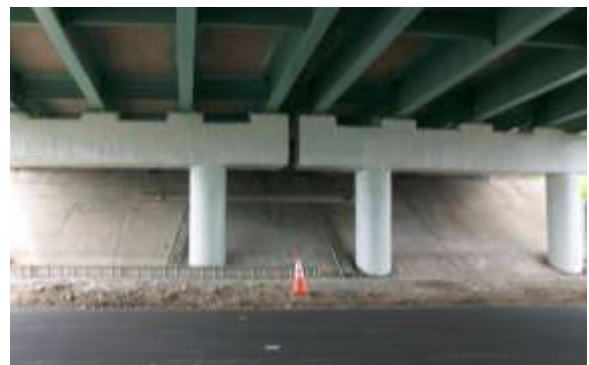
REPAIRED PIERS

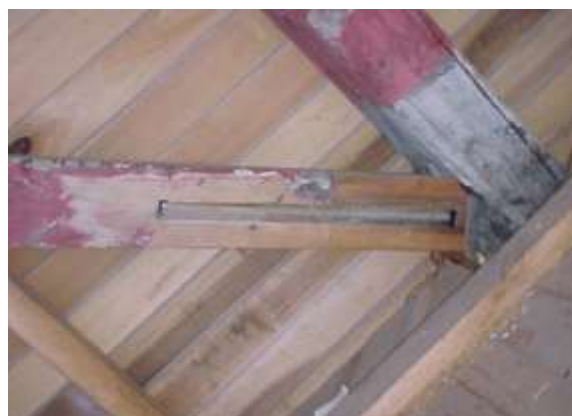
GFRP ROD EMBEDDED INTO DIAGONAL MEMBER

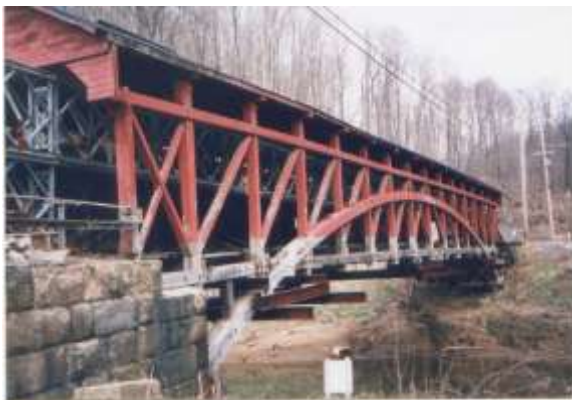
RESTORATION OF MAIN ARCH

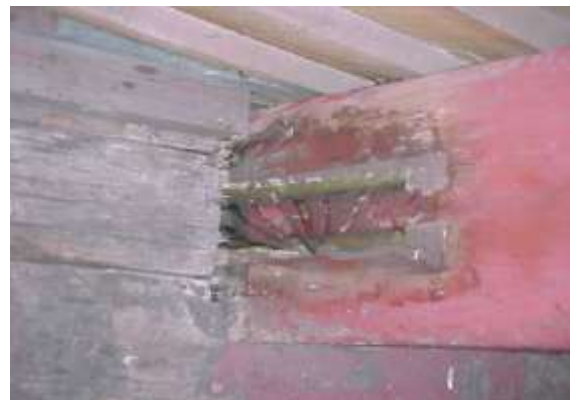
EPOXY GROUTED GFRP REINFORCEMENT

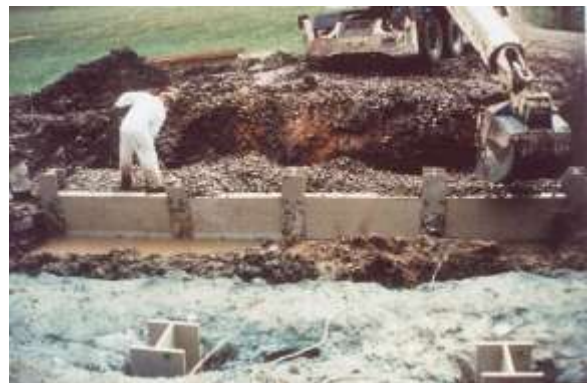
GFRP PILES/CELLULAR LAGGING MODULES

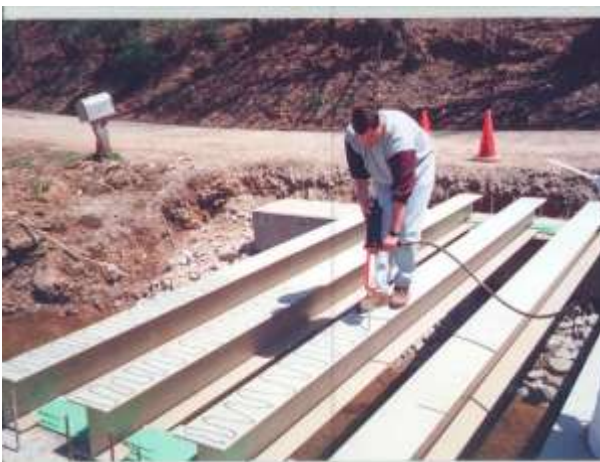
APPLICATION OF PLIOGRIP ADHESIVE TO GFRP BEAMS

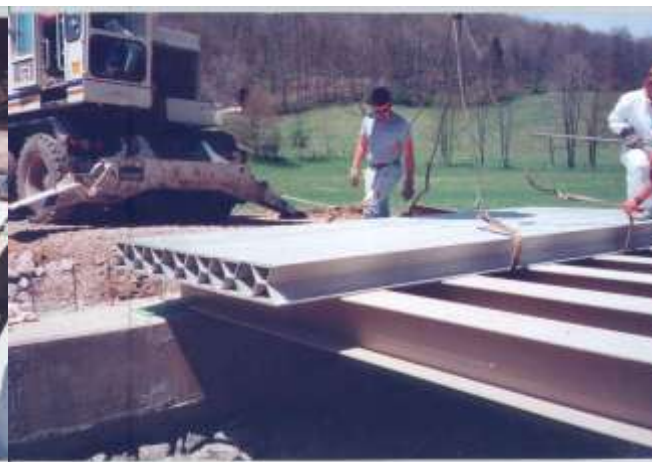
INSTALLATION OF DECK PANELS
